REPORT 1133

MECHANISM OF START AND DEVELOPMENT OF AIRCRAFT CRASH FIRES 1

By I. IRVING PINKEL, G. MERRITT PRESTON, and GERARD J. PESMAN

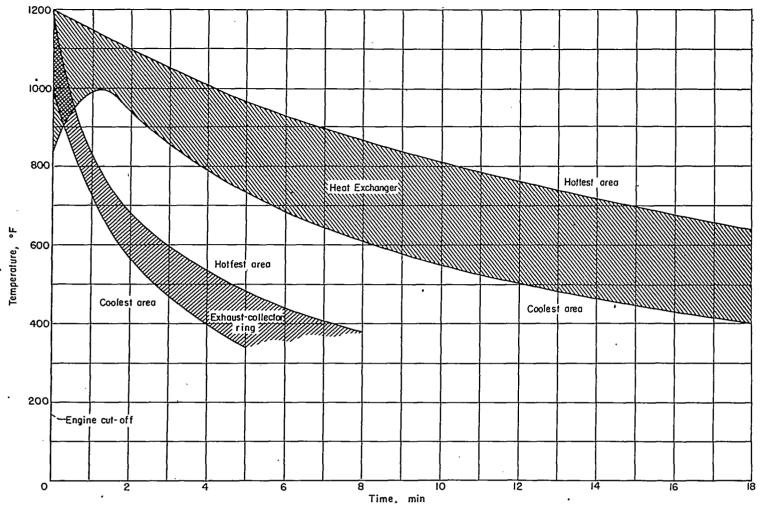
Probability of ignition on hot surfaces is high, because they are present at the moment of crash and remain at dangerous temperatures for several minutes thereafter. The temperature history of the exhaust-disposal system, for example, taken during crash (fig. 6), following operation at take-off power, indicates that it takes 30 seconds for the hottest portions of the exhaust-collector ring to cool to 950° F, the lowest temperature at which gasoline will ignite readily on the external surfaces of the exhaust system, and 84 seconds to cool to 760° F, the lowest temperature at which lubricating oil was observed to ignite readily.

FIGURE 6.—Temperature-time history of exhaust system during crash test.

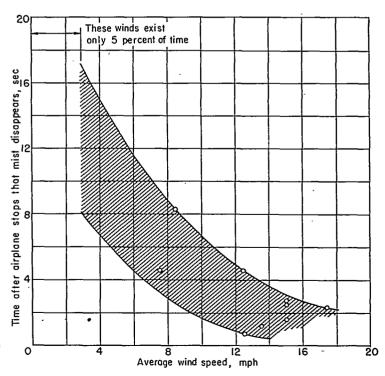
Time duration of mist ignition hazard.—Fuel mists in ignitible concentrations seldom persist around the airplane for more than 17 seconds after the airplane comes to rest. The larger mist droplets rain to the ground, and the air-borne fuel droplets are swept from the area by the wind. In passing from the area of the crash, the fuel mist may be blown over the engine nacelles, and, during the first few seconds of this period, the probability of mist ignition is significant. The hazardous period is short, because the last portion of the fuel mist to pass over the airplane is diluted below the ignitible limit. Even on calm days, the air dragged by the crashed airplane in its slide along the ground sweeps over the airplane when it comes to rest, and brings with it some of the fuel mist suspended in the airplane wake. Fuel-mist dispersal times taken from motion pictures of the crash are plotted in figure 11 as a function of the wind speed. The dispersal time decreases inversely with the wind speed in the expected manner. Because of the large error inherent in making a visual estimate of the persistence time of the fuel mist in the neighborhood of the airplane, indicated by the scatter of the data of figure 11, it was not possible to evaluate the effect of fuel volatility on this persistence time. Fuel

FIGURE 11.—Effect of wind velocity on time after airplane stops that fuel mist remains around crashed airplane.

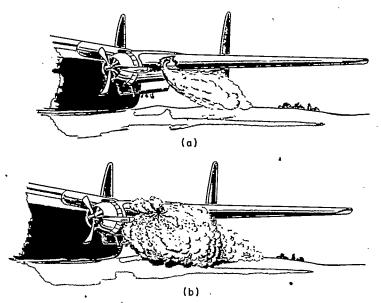
FIGURE 14.—Schematic diagram showing effect of deceleration and airplane speed on spanwise propagation of fuel mist emerging from ruptured fuel tank.

A fuel-mist pattern obtained when the airplane deceleration is low and the speed is high would have the small apex angle and consequent low spanwise extension at the leading edge of the wing shown in figure 14 (a). In contrast, the mist pattern associated with high deceleration and reduced airplane speed (fig. 14 (b)) shows a wide apex angle and appreciable spanwise spread along the wing leading edge.

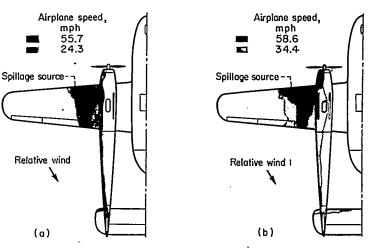
Wetting patterns (fig. 15) obtained with the simulated fuel spillage during the airplane taxiing studies show these effects clearly for four combinations of airplane speed and deceleration. The fuel was replaced by dyed water that issued from the wing at the location indicated in the figures. In figure 15 (a), the wetting patterns on the underside of the wing obtained with a fuel-jet velocity corresponding to a sustained deceleration of approximately 2.5g are less extensive spanwise than those obtained in the case of the 6.4g deceleration shown in figure 15 (b). In both figures, the wetting pattern is broader for the lower airplane speed. In the high-deceleration case, the fuel mist had a forward extension sufficient to wet the propeller blades and cowl inlet. Because the fuel droplets in the mist are air-borne, a relative wind having a spanwise component from the wing tip to the

(a) Deceleration, 2.5.
 (b) Deceleration, 6.4.
 FIGURE 15.—Wetting pattern obtained with simulated fuel spillage during airplane taxing tests.

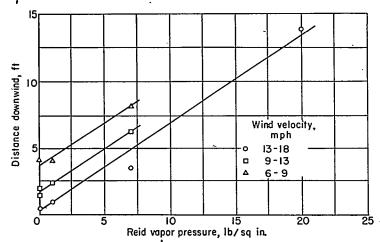
FIGURE 22.—Maximum distance downwind from nozzle rig that flame will propagate upwind as a function of fuel volatility and wind velocity. Ambient-air temperature, 68° F.

an air temperature of 68° F, with a fuel-flow rate of 178 gallons per hour through 17 hollow-cone spray nozzles each having a nominal rating of 10.5 gallons per hour. The data of figure 22 show that, in a given crash involving ignition of fuel mist, the maximum downwind distance the ignitor may be from the point of fuel spillage for the flame to propagate upwind to the airplane through the mist varies directly with fuel vapor pressure and inversely with wind speed. The maximum downwind distance from the fuel source at which upwind flame propagation will occur for gasoline mists (7 lb/sq in. Reid vapor pressure) decreases from 8 to 5 feet when the wind speed is increased from 8 to 18 miles per hour. At a wind speed of approximately 16 miles per hour, a change from gasoline to isopentane (20 lb/sq in. Reid vapor pressure) raises this maximum flame propagation distance from 5 to 14 feet. Because the distances given on figure 22 are a function of the rate of flow of the fuel generating the mist, magnitudes shown are of limited significance. The relative magnitudes given are important, however. These data are consistent with those obtained by the Texas Company in a comparable study (ref. 13), in which the fuel mists were generated by dropping fuel-filled bottles on a concrete platform exposed to a known wind. The presence of the crashed airplane and its debris can modify these results materially by providing wind-protected zones having lower wind speeds than those prevailing generally. The likelihood of upwind flame propagation through the fuel mist along these wind-protected zones is increased over that which would exist in an unobstructed wind.

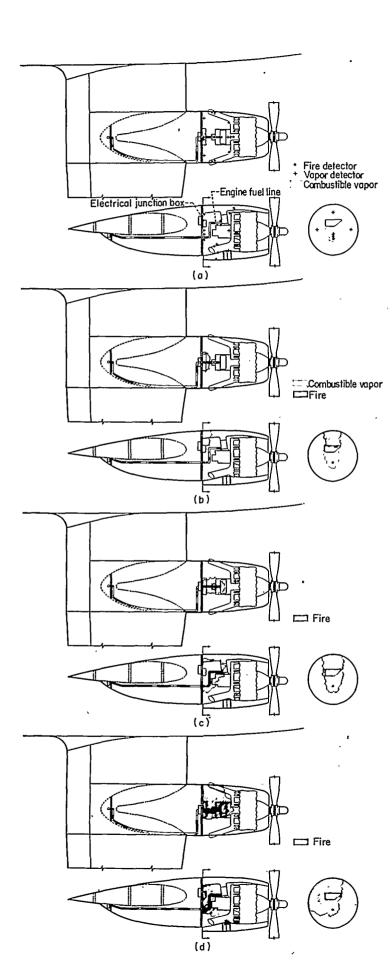
Figure 30.—Spread of fire resulting from ignition of vapor-air mixture in induction-system.

In the crash in which this mechanism of fuel ignition was observed, the airplane involved was equipped with steelbladed propellers. Impact of the propeller with the abutment of the crash barrier produced a rotational displacement of the engine sufficient to rip open the engine induction system and the cylinder exhaust-stack connection to the exhaustcollector ring. The vapor-air mixture released from the engine induction system was ignited by plumes of exhaust flame issuing from the open exhaust stack before the wing fuel tanks were breached by the barrier poles (fig. 30 (a)). At the same time, the crash instrumentation indicated a parting of the engine fuel line in the nacelle produced by the engine deflection. Fuel poured from this line with the fuel booster pump at the tanks operating at normal speed. The fire of the engine induction-system fuel-air mixture ignited the fuel spillage from the broken engine fuel line to produce the fire shown 0.29 second after crash impact (fig. 30 (b)). The air flow around the engine spread the flames into the nacelle wake. The fuel mist issuing from the wing-tank rupture imposed by the poles at the crash barrier was ignited behind the wing, where the spreading fuel mist intercepted the flame extending rearward from the nacelle, as shown in figure 30 (c). At this time the fire had not propagated to the fuel mist under the wing. The resulting wing fire 1.2 seconds after impact is shown in figure 30 (d).

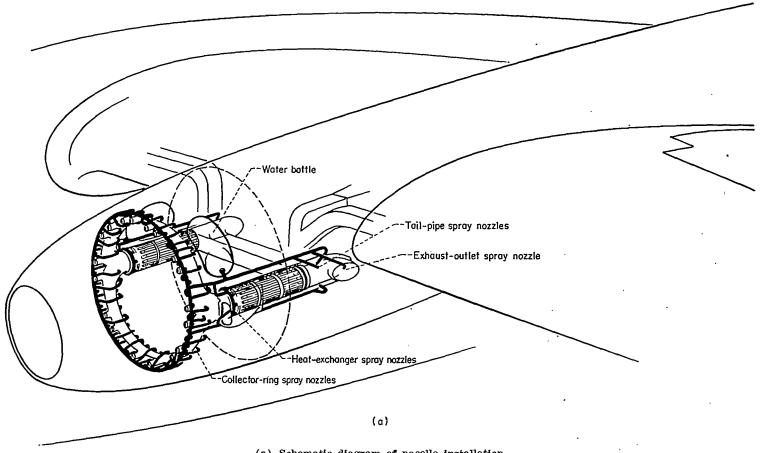
FIGURE 32.-Water-spray system of ignition-source inerting system.

In view of the 760° F minimum ignition temperature of lubricating oil measured on the hot exhaust-collector ring in these studies, some additional consideration of the temperature to which the collector-ring metal is to be cooled is in order. A review of the sequence of events in a crash with the airplane equipped with water sprays leads to the following assessment of the cooling specification: Immediately following crash impact and in the subsequent motion of the airplane's slide to rest, contact between lubricating oil and any part of the hot exhaust-collector ring is quite likely. During this time, water sprays are in operation, a portion of the oil that may be in contact with the exhaust system evaporates along with the water, and the remainder drips from the exhaust system with some of the water. When the airplane comes to rest with engines and oil pumping stopped, further contact between the exhaust system and oil occurs with the oil flowing by gravity. Under gravity flow the contact that does occur will most likely be confined to the lower octant of the exhaust-disposal system. Water sprayed on the exhaust system also drains by gravity to the lower portions of the exhaust-system elements and provides greater cooling in these zones. In general, all elements of the exhaust system considered individually experience greater cooling on the lower portions for this reason. If the water sprays are maintained for about 10 seconds after the airplane comes to rest, those surfaces likely to be wetted by lubricating oil flowing by gravity are cooled to safe temperatures. The quantity of water carried in this system was more than adequate to meet the modest added water requirements for the lower portions of the exhaust system. In the installation employed here, the water-spray nozzles were sized to give a total spray time of 20 to 30 seconds or a flow for 15 seconds or more after the airplane comes to rest. On the basis of observations made in this study, departures from the mode of oil contact with the exhaust system described are considered to have a low probability of occurrence unless a large degree of distortion and displacement of the exhaust system occurs in the crash.

FIGURE 32.—Concluded. Water-spray system of ignition-source iner ing system.

The fourth element of the ignition-suppression installation was a system of water sprays distributed to give a simultaneous uniform coverage of the hot metal of the exhaustdisposal system and the associated tail-pipe heat exchanger. The water spray served the twofold purpose of rapidly cooling the hot metal to safe temperatures and providing, meanwhile, a protective blanket of steam generated on the hot surfaces that inerts the adjacent atmosphere. Water was the fluid selected for this purpose because of its high heat of vaporization and low molecular weight. Relatively small weights of water provided effective cooling and generated large volumes of inerting steam in the high-temperature zones adjacent to the hot metal. A consideration of the heat capacity of the hot metal of the exhaust-disposal system and the heat exchanger and the temperature drop of 250° F required to reduce the metal temperature from the maximum temperature of 1200° F at the moment of crash to the lowest exhaust-system surface temperature at which gasoline will readily ignite (950° F) yields a water requirement per nacelle of approximately 1/2 gallon for the C-82 airplane. In order to provide a safety factor, 4 to 6 gallons of water were employed for each nacelle.

The essential elements of the water-spray system are shown schematically in figure 32 (a). The water, contained under nitrogen pressure of approximately 400 pounds per square inch, was distributed to all hot metal elements of the engine exhaust system through the 34-inch-diameter manifold shown in figure 32 (b). The spray nozzles and branch lines terminating in spray nozzles are required to provide uniform water coverage of the hot metal parts. In order to provide rapid cooling of the hot metal, water was also sprayed into the interior of the exhaust system at six equally spaced locations, one of which is visible in figure 32 (b) at the junction-of the tail pipe with the collector ring. The equivalent water-spray installations for the exhaust-gas heat exchanger are shown in figure 32 (c). The necessity for providing a protective blanket of steam around the external surfaces of the hot metal, where contact with combustibles may occur, while it cools to safe temperatures, fixes the external appli-

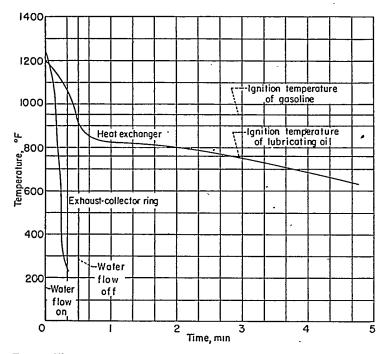
FIGURE 35.—Temperature-time history of hottest portions of exhaust system during crash test. Heat exchanger and exhaust-collector ring water-cooled and inerted.

When the water spray was employed, the hottest areas of the exhaust-collector ring cooled in 12 seconds from an initial temperature of 1250° to 760° F, the lowest temperature at which lubricating oil ignites on the external surfaces of the exhaust system (fig. 35). The exhaust-gas heat exchanger cooled to temperatures safe for gasoline in 30 seconds. Contact between the hot areas of the heat exchanger and the lubricating oil is highly unlikely, and rapid cooling below 950° F is not required. The relatively stagnant atmosphere of steam within the heat exchanger continues to protect this zone until the heat exchanger cools by radiation and conduction to other portions of the airplane structure.

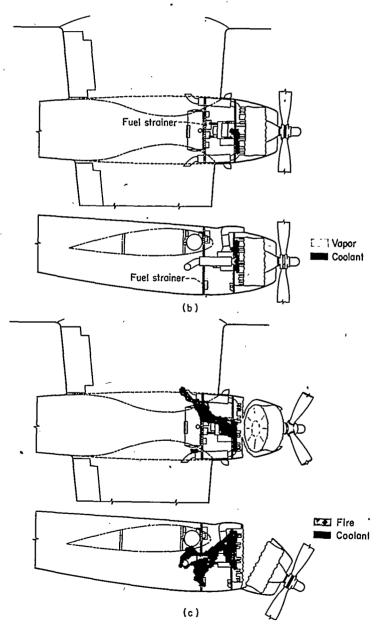
Three-quarters of a second after crash impact, the instrumentation showed the situation existing in the nacelle illustrated diagrammatically in figure 38 (b), which depicts the pertinent nacelle accessory-section layout and location of the fire and vapor detectors. At this time, the only combustible mixture indicated was located close to the damaged fuel strainer fastened to the face of the fire wall at

- (b) Schematic diagram of nacelle showing location of combustible vapor and coolant in nacelle 0.75 second after initial impact.
- (c) Schematic diagram of nacelle showing fire indicated by detectors in nacelle 4.2 seconds after initial impact.

FIGURE 38.—Mechanism of ignition by hot metal of exhaust-collector ring.

of the airplane at this time (fig. 38 (a)) moving at approximately 60 feet per second shows the marked forward development of the fuel mist close to the ground and the vertical inclination of the engine and cowl. Some of the water spraying uselessly from the damaged water manifold can be seen projecting vertically from the nacelle. At 3.8 seconds after crash, the first evidence of fire appeared between the 12 and 1 o'clock positions on the exhaust-collector ring. The initial flame that appeared at this position did not show in the printed figure. In figure 38 (d) is shown the flame after it propagated to the 11 o'clock position.

At 4.2 seconds, fire-detector thermocouples first registered over the broad zone indicated in figure 38 (c). Failure of the fire-detection thermocouple to register at the 1 o'clock position on the exhaust-collector ring where the fire first appeared before 4.2 seconds is attributed to wetting by the

water spray. Instrumentation that recorded the actuation times of the inerting-system components showed that they functioned properly. Therefore, the unprotected exhaust-collector ring is the most probable ignition source, as is consistent with the visual evidence. Migration of the fuel mist to the inboard side of the nacelle was required in order for ignition to occur, because the top of the outboard segment of the exhaust-collector ring was under water-spray protection. That the fuel mist did extend to the inboard side of the nacelle is evidenced by the flame showing around the nacelle on the inboard side in the photograph of figure 38 (e), taken immediately after ignition.

After the first crash in this series, the water-spray system was mounted to remain with the exhaust-disposal system should the engine be displaced, and carbon dioxide was employed at the engine inlet because it does not decompose appreciably at engine exhaust temperatures. In the next six crashes, one ignition occurred by the movement of fuel through the hot-air duct to the exhaust-gas heat exchanger. as was described in the discussion of liquid-fuel spillage. This result called attention to the need for more careful distribution of the water spray in the heat exchanger and to the desirability of a safety gate in the hot-air duct. After coming to rest, the other five unburned crashed airplanes carrying the inerting system appeared as shown in figure 40. The only visible evidence of the presence of the inerting system was the volume of water vapor issuing from the nacelle. On humid days, the condensed water vapor persisted in the atmosphere long enough to have the appearance shown in some of the photographs.

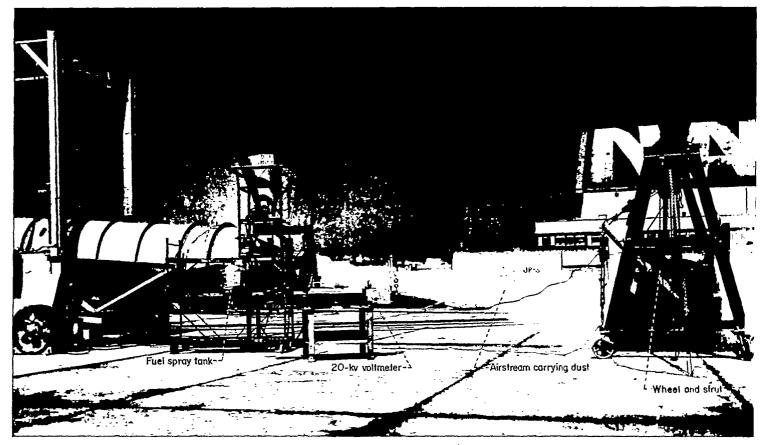
case was most likely produced by electrostatic discharge from the strut to the ground. Studies were made with the same wheel and strut, electrically insulated from the supports, as shown in figure 46. Air was blown over the wheel and strut assembly by the blower shown in the figure, and dust was metered into the air stream. A dust flow rate of 400 grams per second with an airspeed of 45 miles per hour past the strut generated 3900 volts, sufficient to produce sparks capable of fuel ignition in less than 0.75 second (fig. 47). In the crash, the wheel and strut traveled through the air at 43 miles per hour for 1 second, bounced on the rubber tire, and then traveled through the air for another 1-second period at approximately the same speed.

FIGURE 46.—Test setup to determine rate of accumulation of electrostatic charge on a landing-gear strut.

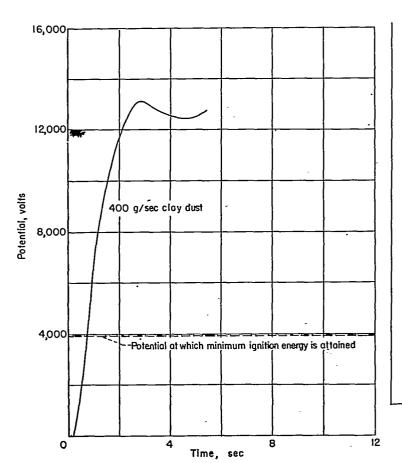
FIGURE 47.—Voltage produced on insulated landing gear by blow clay dust at 45 mph. Leakage resistance, 0.5×10^{12} ohms; capt tance, 200×10^{-12} farad.

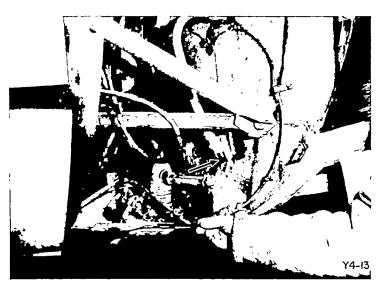
FIGURE 48.—Fuel line cut by flying propeller tip.

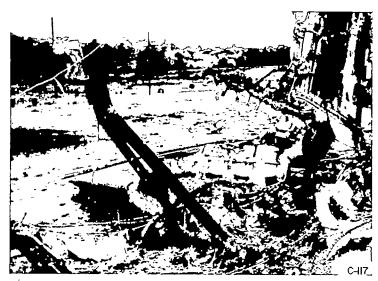
FIGURE 63.—Structural elements melted in a typical crash fire.

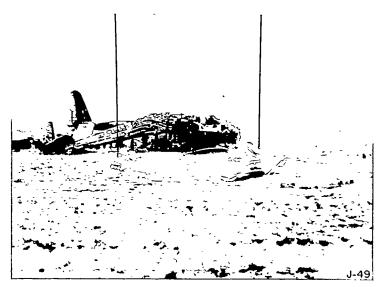
FIGURE 64.—Structural collapse due to melting and burning of skin and structural memliers.

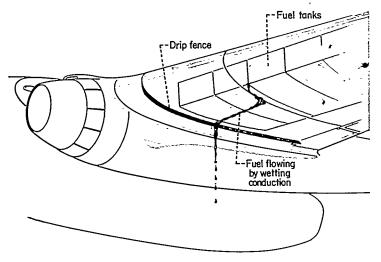
FIGURE 67.—Drip fence to prevent spanwise flow of fuel from fuel tanks to nacelle by wetting conduction on lower surface of wing.
